Failure Analysis of a Weld Neck Flange of the Discharge Piping of an Ethylene Compressor in a Petrochemical Complex

By Okpala, Alexander N

Niger Delta University, Wilberforce Island, Bayels A State

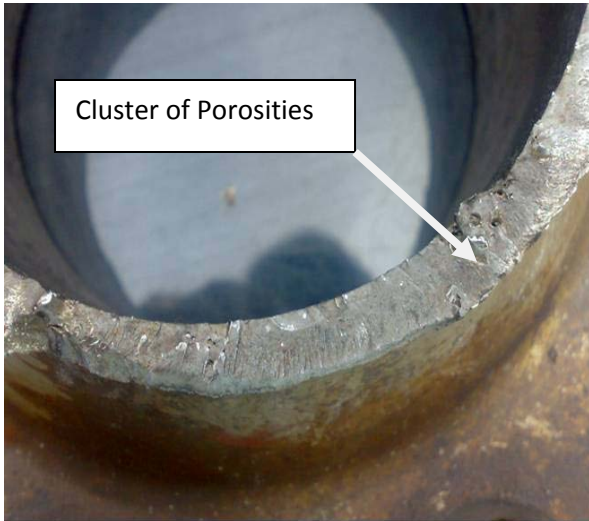
The 8" piping that branches out from the main discharge piping of an Ethylene compressor, failed after thirteen years of service life. The pipe carries ethylene gas at approximately 27k/cm² at 75-80°C. The failure took place on the upstream side of a pressure safety valve (PSV) in the discharge piping of an ethylene compressor around the HAZ between the 4" weld neck flange and the weldment of the 4" to 8" reducer. The reducer was completely snapped (fractured) off from the weld-neck flange. This was attributed to process upset. Photograph of the failure weldneck flange is presented in figure 1. This paper presents the failure analysis carried out with the aim of finding the root cause.

Fig 1 : Failed PSV Weld neck flange showing porosities

1. The flange used for replacing the failld one should be sourced from vendors that can guarantee the use of vacuum degassing after forging as this has been found to reduce hydrogen to less than 3ppm in forgings which ultimately preclude the possibility of hydrogen embrittlement.
2. The flange used for replacing the new one should be subjected to normalizing heat treatment at 910°C for 30minutes as research work carried out by Belgian Welding Institute for a material of similar composition revealed that

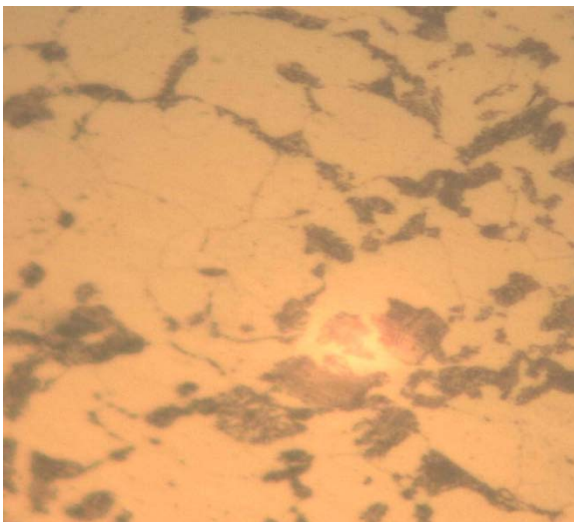
The micrograph of the fractured weld-neck flange of the pressure safety valve presented in figure 2, shows coarse grain microstructure and the presence of widmanstatten ferrite. The metallographic examination

revealed that the microstructure and grain size vary considerably with the maximum and minimum ASTM grain size numbers being 3 and 6 respectively. The grain sizes of the samples were determined in consonance with the requirement of ASTM E 112. The un-etched specimen presented in figure 3 shows a number of porosities.

Fig 2 : Micrograph of weldneck flange of PSV, 2% nital etched x 800

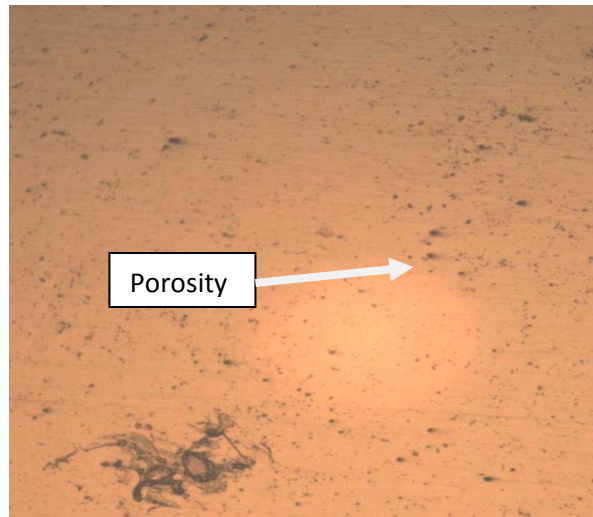
Fig 3 : Micrograph of weldneck flange of PSV, unetched x100 showing porosities

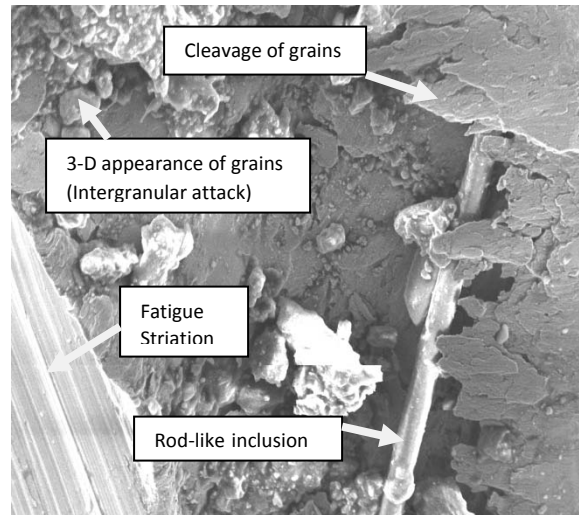
The SEM fractograph of the weld neck flange of pressure safety valve presented in figure 4 shows the three-dimensional nature of the various grains which is typical of (brittle) intergranular fracture as opined in Davis(1998). The figure also shows various cleavages which is typical of (brittle) transgranular fracture. The fatigue striations revealed by this fractograph are

characteristic of fatigue failure. Another very prominent revelation of the SEM fractograph of figure 4 is the presence of a continuous threadlike rod of inclusion which is a very likely point of crack initiation. The fractograph in figure 5 shows clearly the transgranular fracture in a cleavage. Figure 6 fractograph of this sample shows mainly transgranular and intergranular and intergranular failure nodes. It could therefore be inferred that the failure of this sample was catastrophic and was to a largely extent by brittle mode. The inclusion and blow holes in figure 3 as well as the dark particles in this micrograph are a pointer to manufacturing flaws in the flange.

Fig 4 : Fractograph of failed weldneck flange of PSV x500

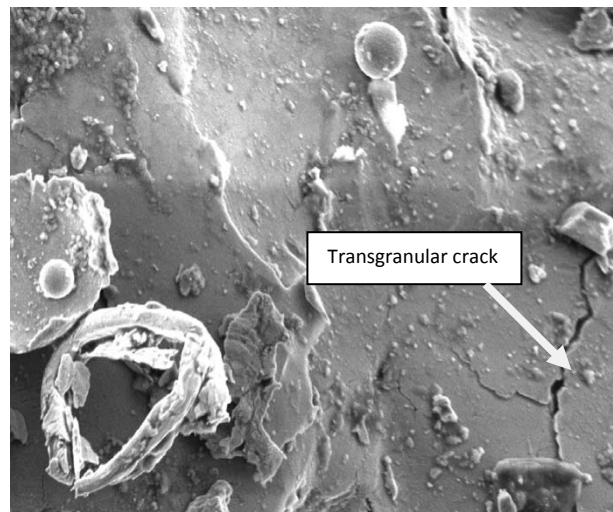
Fig 5 : SEM Fractograph of failed flange of PSV x700

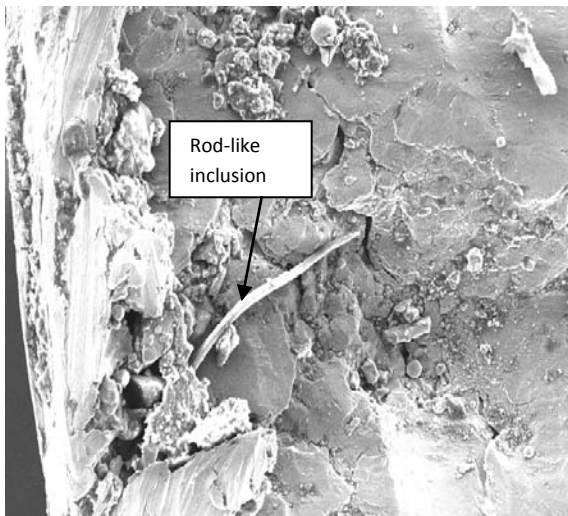
Fig 6 : SEM Fractograph of failed flange of PSV x300
