# Rework Reduction of Gaps and Alignments in an Automobile Assembly Plant

By Anand Umrani & Harshvardhan Uttarwar

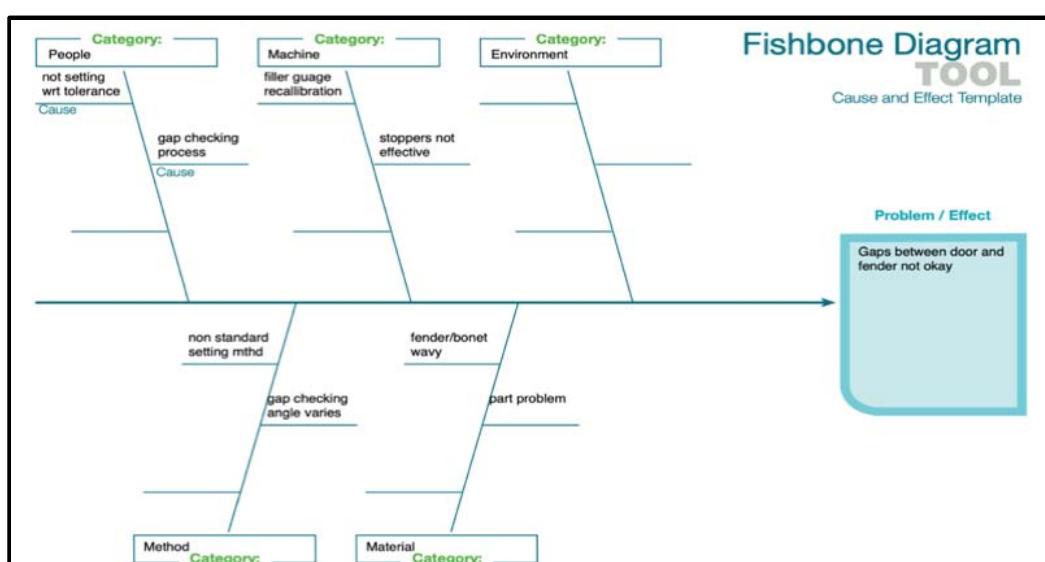
Figure 1: Cause Effect Diagram

The cause effect diagram revealed that the operator checking process for gaps and alignment was improper and could be a potential cause of excess variation. Another plausible cause identified was irregular recalibration of filler gauges rendering them to show incorrect values of gaps.

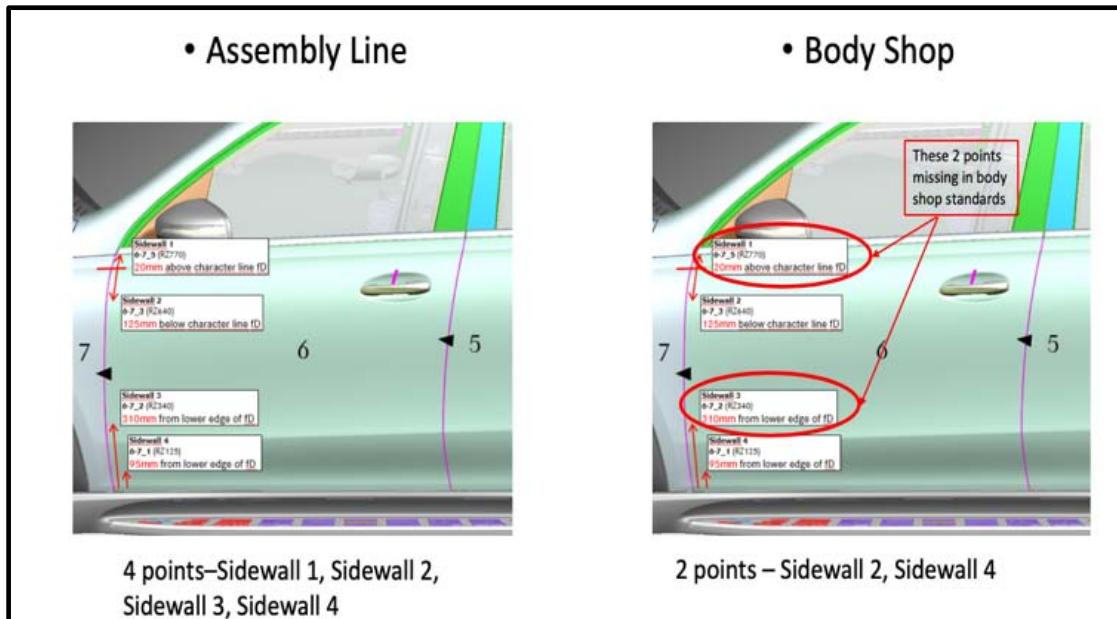
Figure 2: Door to Fender Checkpoints

The two checkpoints between door and fender of the car, highlighted in the figure are not checked at the Body shop quality-check workstation. Since Body shop operators do not put any kind of effort to bring

these points in specified tolerance limits, it takes much more time for Assembly line operators to adjust the gaps at these checkpoints.

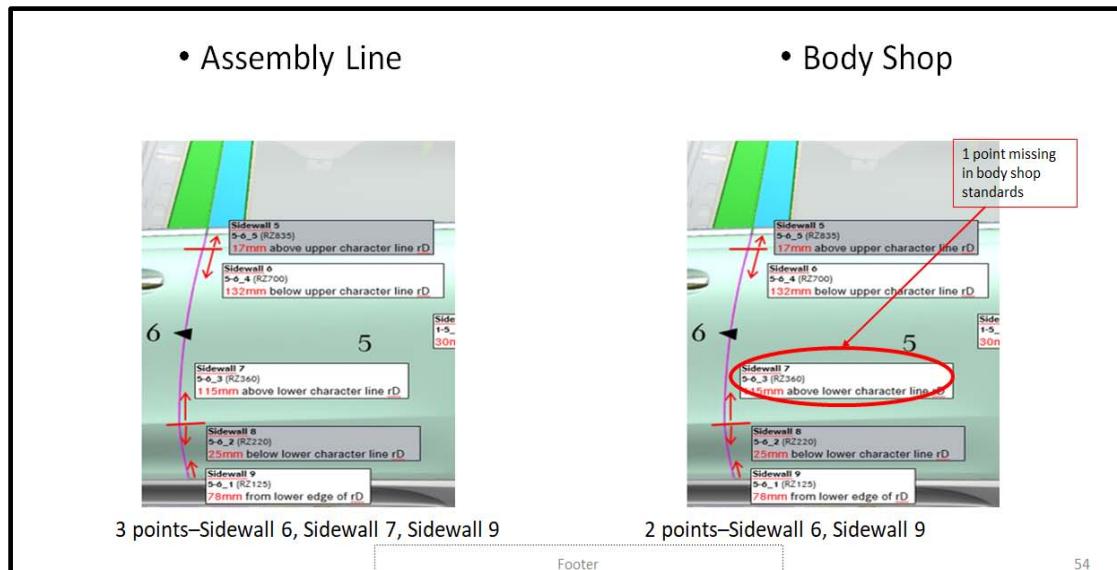
Figure 3: Door to door checkpoints

The checkpoint highlighted here, between 2 doors of the car is missing in list of specified Body shop checkpoints.

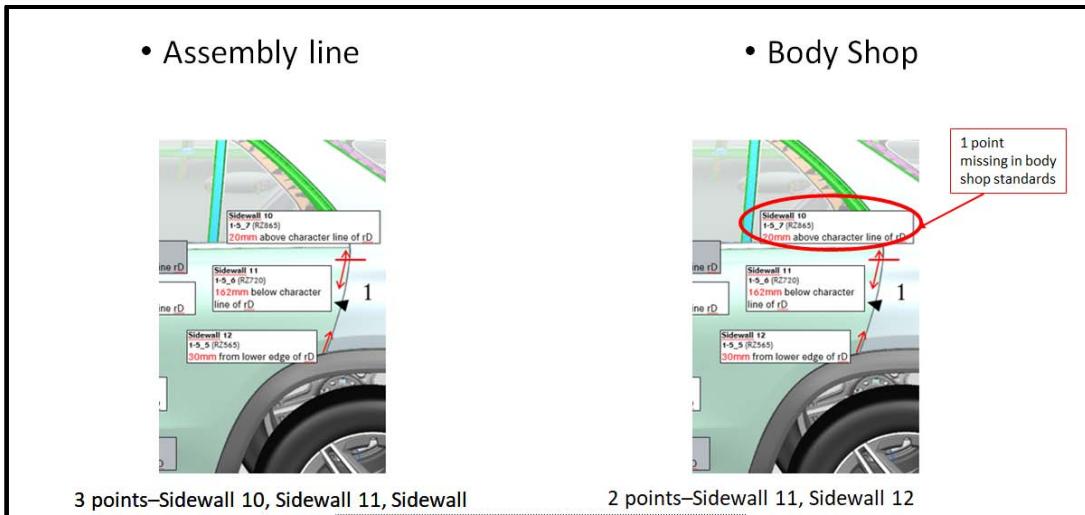
Figure 4: Rear Door to Sidewall checkpoints

The 'rear door to sidewall' of the car had three checkpoints at Assembly line quality-check workstation

whereas Body shop quality-check workstation had two checkpoints.

- Gap 4 (Door to Rear Sidewall) – No major observation, checkpoint should be added for Body shop quality-check workstation which would result in greater frequency of conforming gaps.

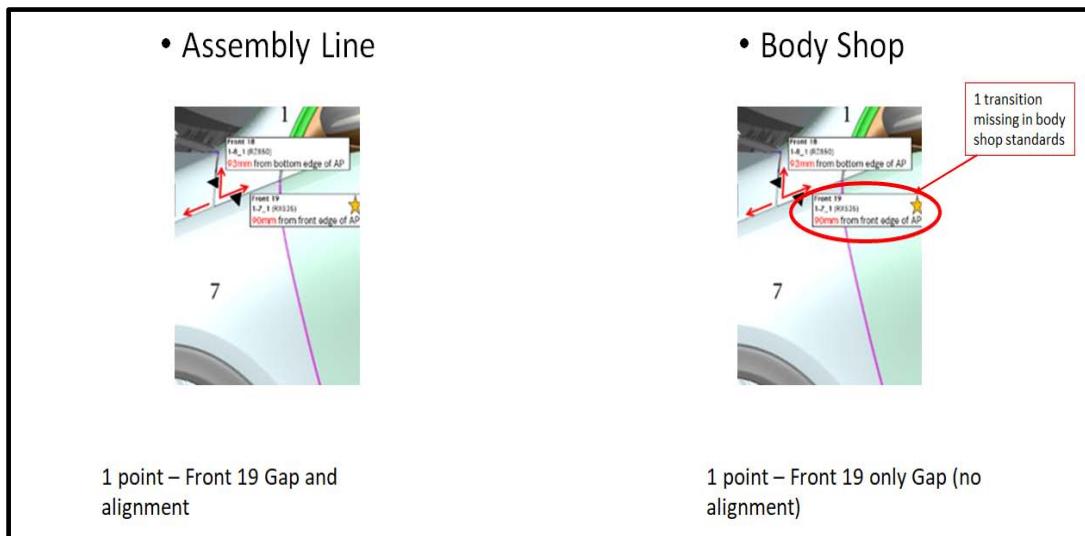
Figure 5: A-pillar to Fender checkpoint

Similarly, the highlighted checkpoint in fig. 5 was measured for gaps at the Body shop but the alignment was not measured whereas tolerance limits for alignment were specified at Assembly line.

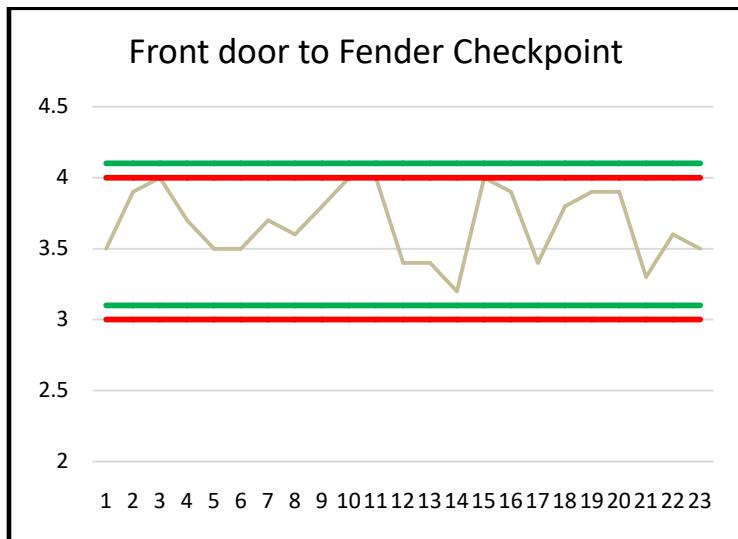
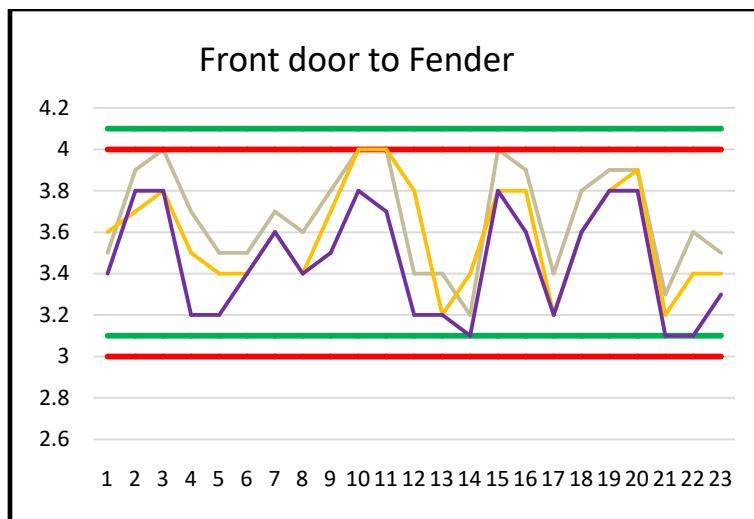
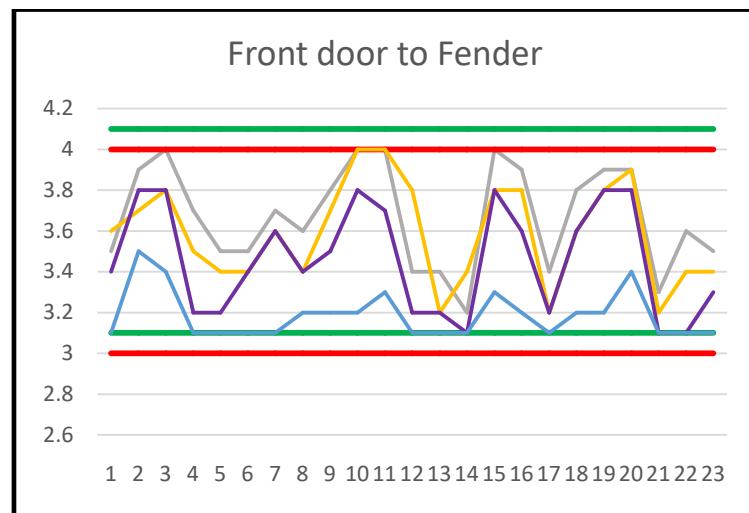
- Gap 3 (Door to Fender) – Body Shop should keep Gap 3 in upper tolerance for it to be within specifications when car reaches Assembly line. But when Gap 3 is kept within specifications at workstation 18 of Assembly line, another checkpoint between door and fender would not conform with its respective assembly line tolerance limits ( $>4.5\text{mm}$ ) and hence, standards need to be revised.

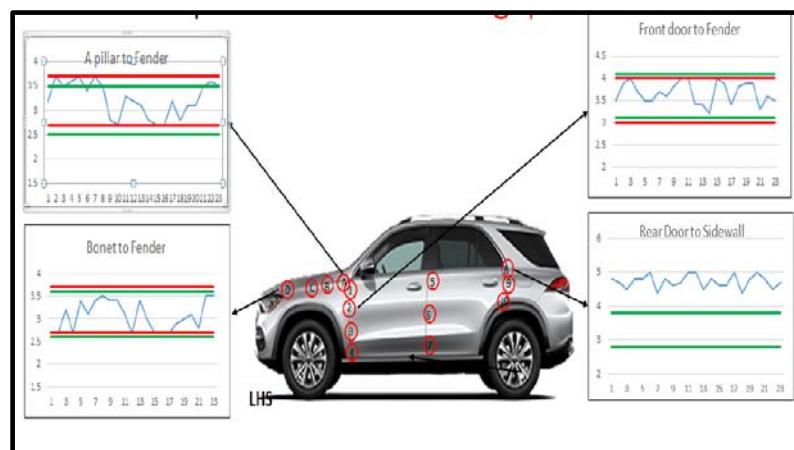
Figure 12: All four checkpoints at Body shop quality-check workstation

- Body shop has no checkpoint for one of the points that was monitored (rear door to sidewall).
- Measurement of gaps Panorama workstation are consistently 0.1-0.2 mm lesser than gaps measured at Body shop quality-check workstation. This is due to the layer of paint that is applied when the car goes to Paint shop after Body shop.

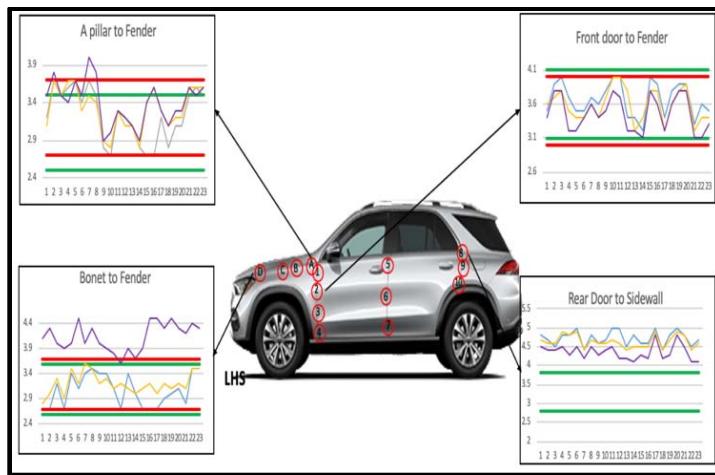
Figure 13: All four checkpoints at Panorama workstation and workstation 18 before setting on Assembly line

- There is a change present in gaps and alignments measured at panorama station and station 18. Hence, assembly process is responsible for some variation which means tolerance limits for Body shop and Assembly line should be different.

- Gap 1 (A pillar to Fender) – No substantial variation between Panorama and St. 18 Before Setting which suggests Body shop output quality is the reason for rejection of cars.
