## Effects of Flood on Infrastructural Development in Uyo Metropolis, Akwa Ibom State, Nigeria

By Anthony Adomi Mbina & Edem, Ephraim E

*University of Uyo, Nigeria*

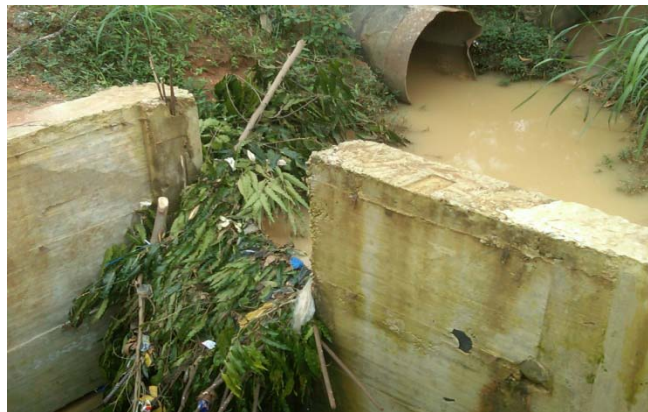
In all the six flood areas, the open v-shaped drains are used especially as street drains; covered drains are, however, used in some buildings at Ewet/Uruan street flood areas, which are also seen connected from compounds to the street drains (Plate 1).

Plate 1: New Drain channels under construction at Uruan Street

The Ikot Ekpene road (near former AKTC) and Uruan street drains are channeled to a covered cesspool and soak away pit. These pools trap water in order to control its percolation into the earth after heavy of rain. Many of the drains need removal of sand from drain, to help the water flow quickly from these flood areas.

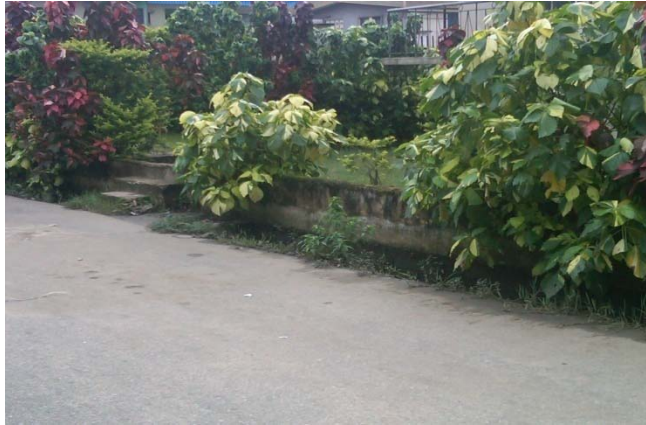
Out of the flood areas under study, vegetation is notably used for erosion control purposes in the middle of Nsentip flood area. This vegetation (ornamental plants) is used to support the fence walls ( Plate 2).

*Plate 2 :* Flood Control at Nsentip street flood area.z

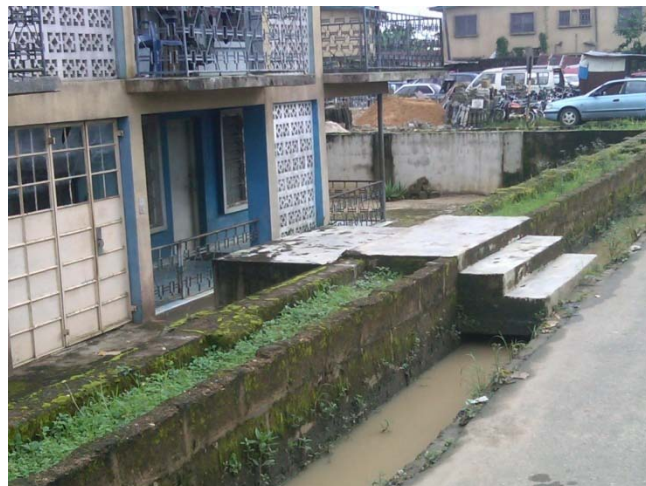
As illustrated in Plate 3, most buildings have 125mm ground floor levels above the natural and assumed ground level. This implies that the foundation foot is approximately 450mm from the natural ground level. It was discovered that dwarf walls of various heights were introduced to stop flood water that exceeded the ground floor levels of these buildings.

*Plate 3:* Sunken compound at Nsentip Street flood area

In Udo Eduok street flood area, residents have fence walls to keep water from entering their compounds. Vehicles were seen packed outside these compounds due to challenges of driving them above these fences into the compounds. (Plate 3).

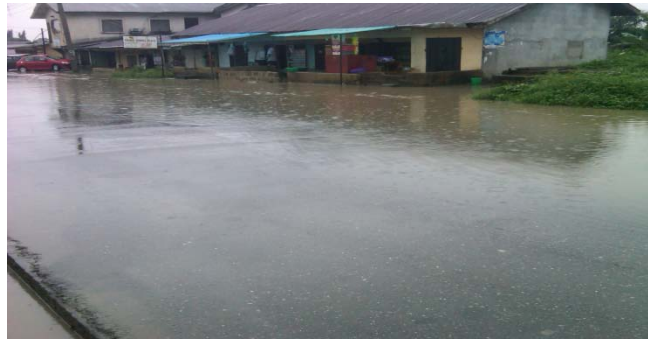
The highest flood level in the area was seen at the Nkemba street/Abak road junction. Through flood, water is trapped in the junction and as a result, people are seen washing their vehicles using the flood water,

the opposite buildings to the Nkemba Street at the junction are sunken below the road level, especially in the premises of the Church of Christ, Afaha Inang (Plate 4).

Plate 4 : Flooded Abak Road by Nkemba Junction

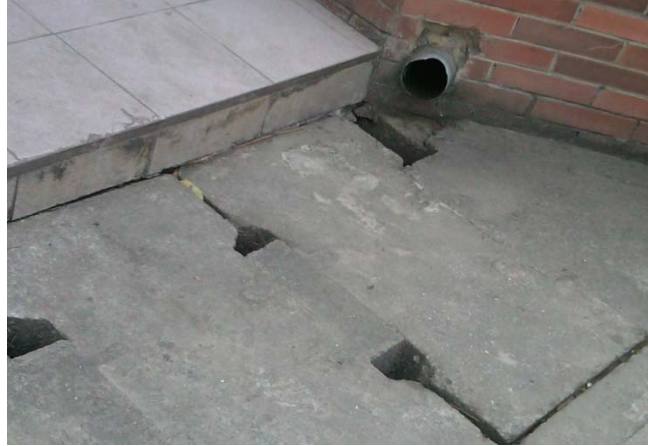
development can be summarized in its coordinated flood control measures as seen in the underground flood drains and sloppy interlocking stone floors (See plates 5 and 6).

*Plate 5 : Underground drains at Ibom Plaza*

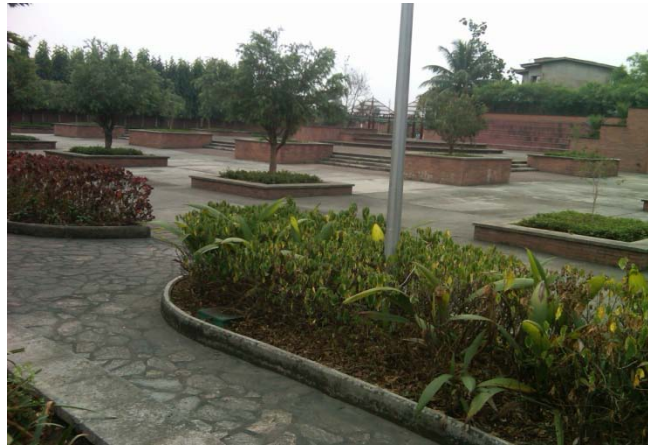
*Plate 6 : Landscaped Ibom Plaza including stone floors*

The sloppy nature of the finished floors aids in draining run-off water to the drains. The Ibom Plaza is a resort that hosts facilities such as shopping malls, business centres, parking lots, games centre, eateries and a gothic Greco-Roman model of a sitting area or amphitheatre with luminous fountains and a giant elevated screen beamed through satellite.

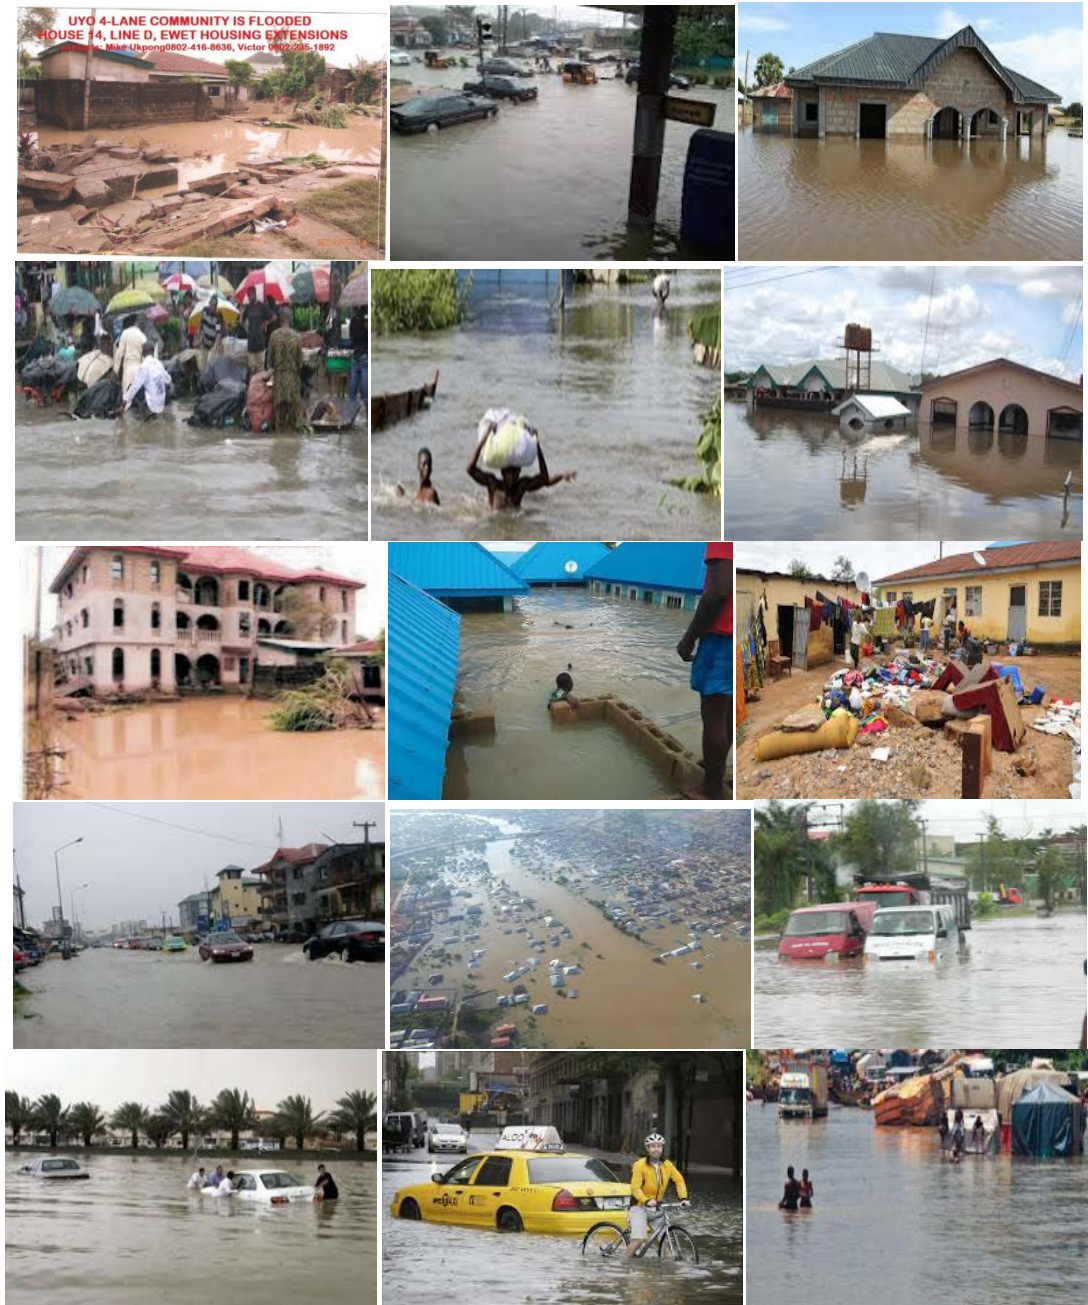
Plate 7 : Examples of Flooding in Uyo Metropolis
