Demonstrative Study of the Effectiveness of Low Cost Gully Rehabilitation Measures: The Case of Bonk District SNNPR, Ethiopia

By Wudnesh Naba, Birhanu Wolde & Abiy Gebremichael

Keywords: *check-dam, grasses biomass, gully rehabilitation, low cost.*

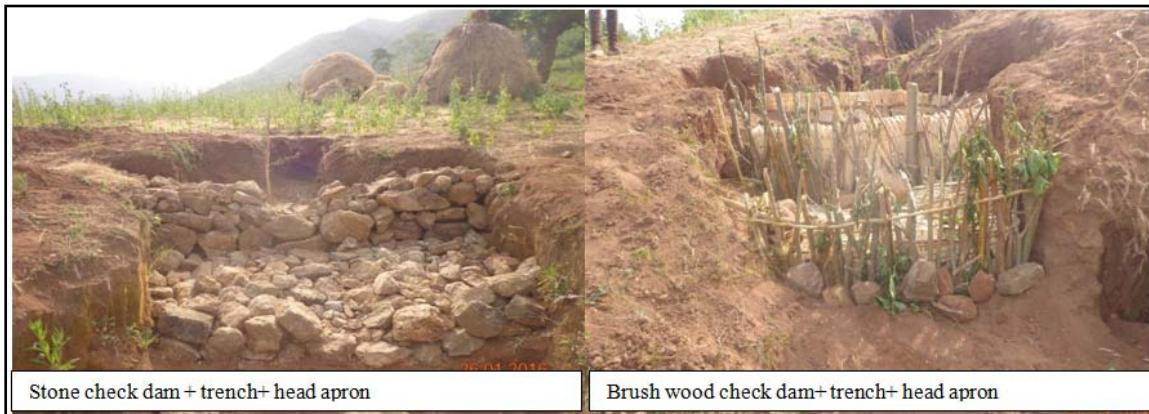
Figure 3: Gully treatments just after construction

A reconnaissance survey was conducted to get a better understanding of the district and select a specific study site. Following the reconnaissance survey, six gullies that have similar dimensions (2-3m depth and 1-3m width) near the head gully was preferred for evaluation. Three treatments (Brushwood check dam+ trench+ head apron, brushwood with stone check dam+ trench+ head apron, and Stone check dam+ trench+ head apron) each were applied on any other two gullies as a replicate. The dimension of trenches in the ravine was 50cm deep and 1m widespread that is extended to 0.5m on both sides of the channel. The spacing (S) of check-dam was determined by dividing the height (H) of check-dam to channel gradient in decimal number and multiplying by a correction factor of 1.2. The check-dams have the height of 1.3m, top width 0.52m, and base width of 2.5m

while the base width of drop structure and head apron is 2m.

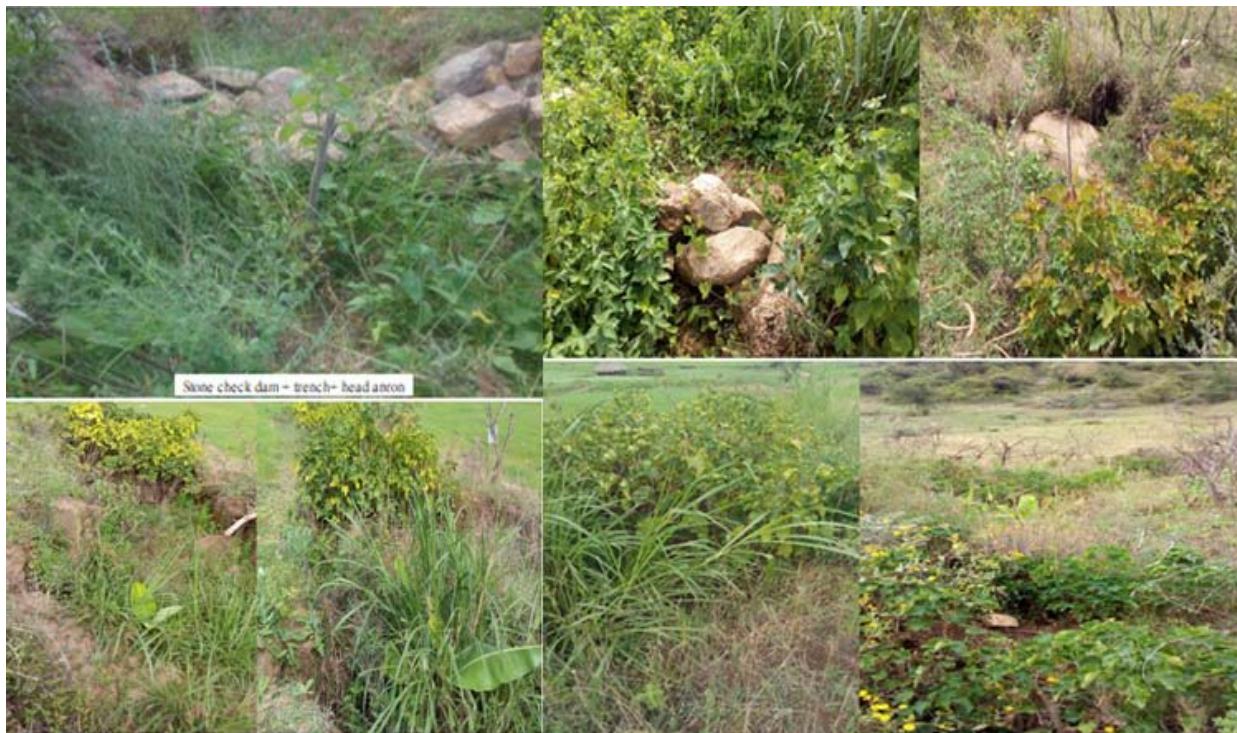
The Photograph at Figure 5 indicated that vegetative stabilizers are matured and strongly supported the structures. Jatropha played a excessive role at this regard. Planting Jatropha not only

maintenance of gully rehabilitation, but also provide multiple uses like fuel (Brittaine and Lataladio, 2010). Besides to being stabilizer for check-dams in the picture above, banana and elephant grass well performed and can provide additional benefits now and onwards.

Figure 5: Gully stabilized with different check-dams and vegetative materials after two years

The change in rehabilitation resulted in the observation of different plant species in the area (Figure 5 & Table 1). The new grass and shrub specie types of about 18 were observed after two years of rehabilitation. Table 1 below indicates that the rehabilitation of smaller
