GLOBAL JOURNAL OF SCIENCE FRONTIER RESEARCH: H
ENVIRONMENT & EARTH SCIENCE
Volume 20 Issue 4 Version 1.0 Year 2020
Type: Double Blind Peer Reviewed International Research Journal
Publisher: Global Journals
Online ISSN: 2249-4626 & Print ISSN: 0975-5896

Application of Lineament Analysis in Geohazard Studies in Mukuru Area Boki Lga Cross River State Nigeria

By Egesi, N. & Agbebia, M. A.
University of Port Harcourt

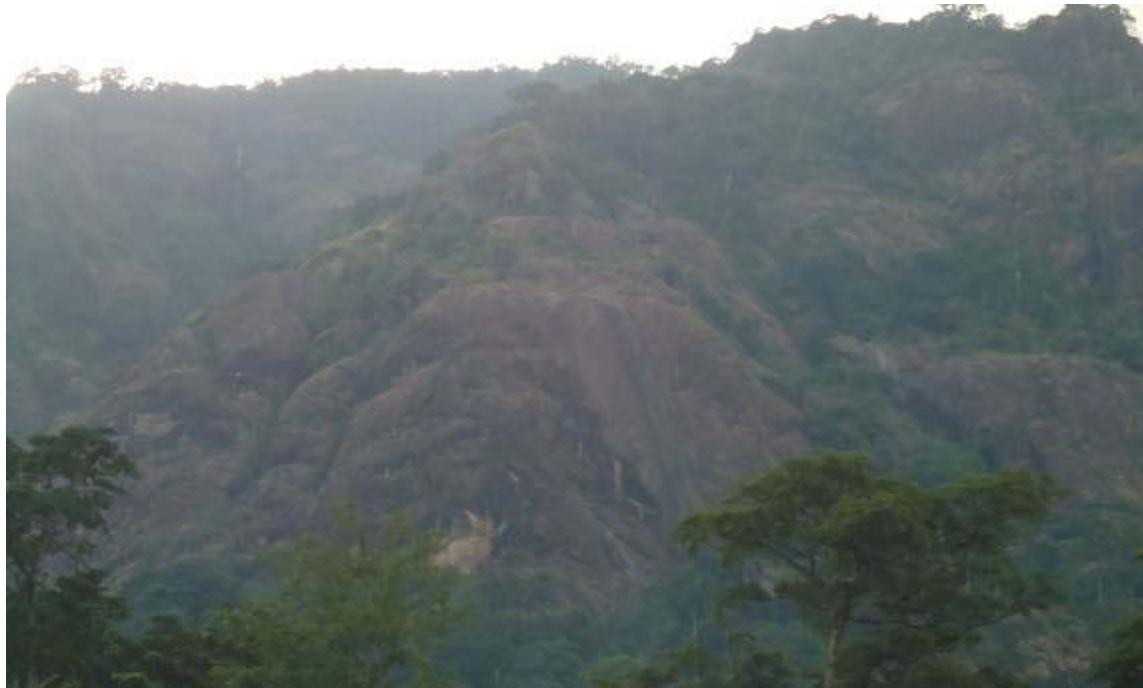
Plate 1: Field photograph of massive charnockitic rocks at Buanchor hills before the rockfalls and rockslides

occurrence. Plate 1 is part of massive charnockitic rocks in Buanchor area before the rockfalls and rockslides which occurred in the area due to human activities at the foot of the highlands after a heavy rainfall and storm.

is on plate 3, compared with plate 1 before the event (Okeke *et al.* 2019). The slope values range between 0 - 2.8m and 61.224 – 89.725m also displaying aspect of high intensity.

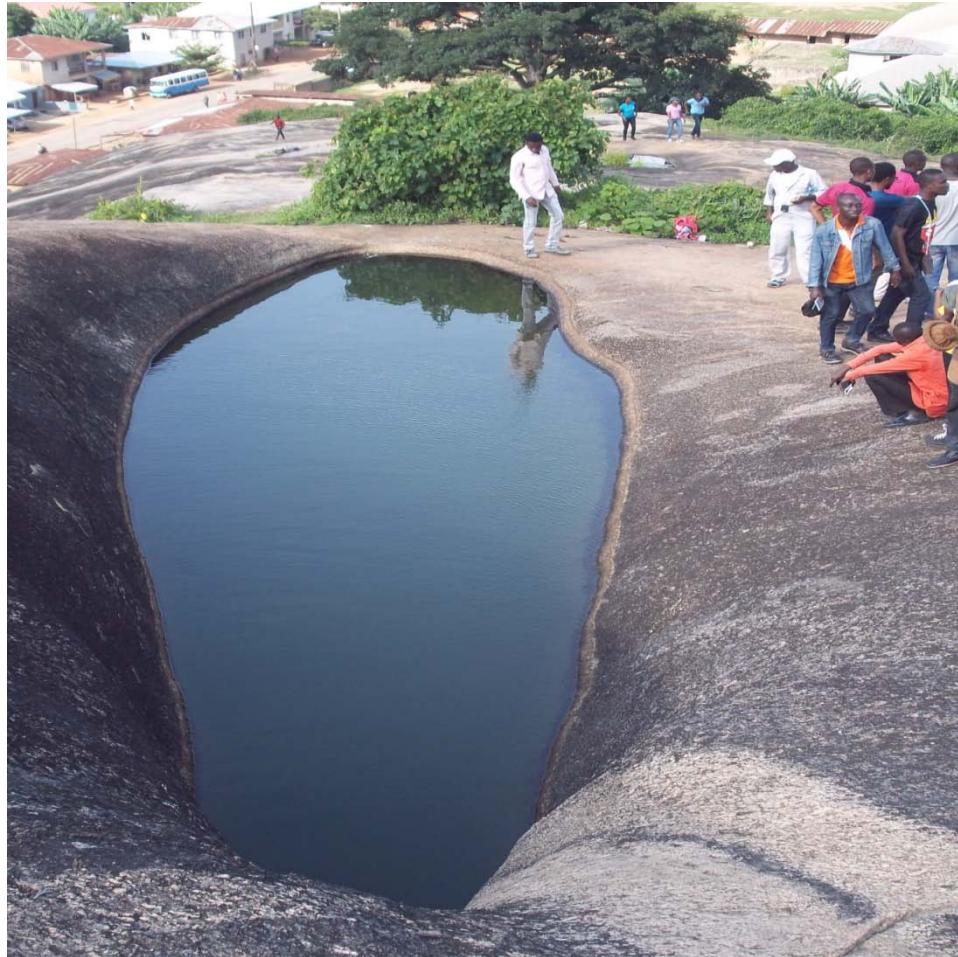
Plate 2: Field photograph showing a 3m deep lake on top of biotite granite a potential geohazard feature

threat to safety of lives and properties. The plate 2, below is a lake on top of biotite granite rock which if it is large enough, under large storms favourable conditions can release the water and other rock materials contained after a heavy rainfall to the lowlands where communities are residing. The effect which may be hazardous, will be similar to the collapse or failure of a water dam. There is need for a controlled release of the water in the pond to safeguard inhabitants living at the lowlands.

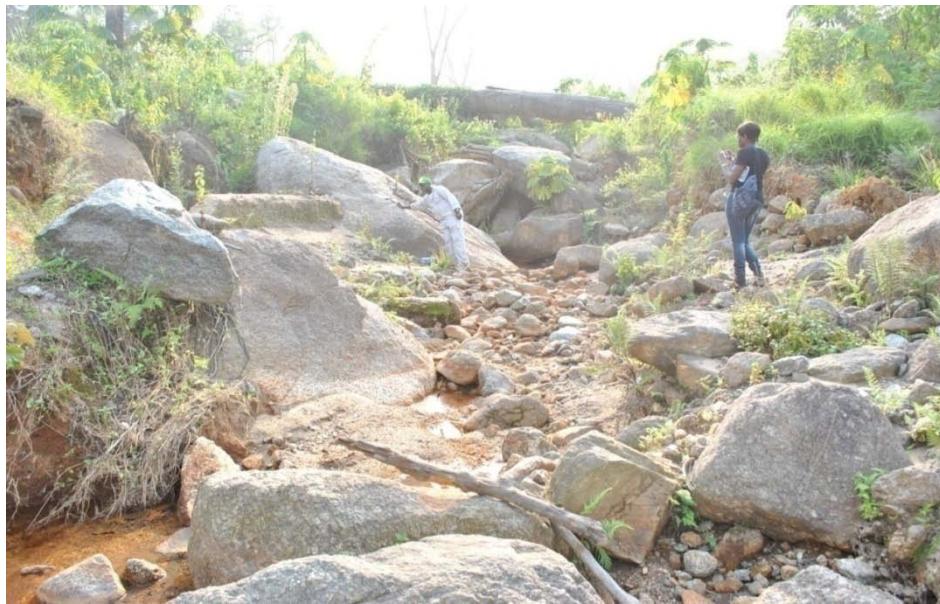
Plate 3a: Field photograph near the foot of Buanchor hills after the rockfalls and rockslides

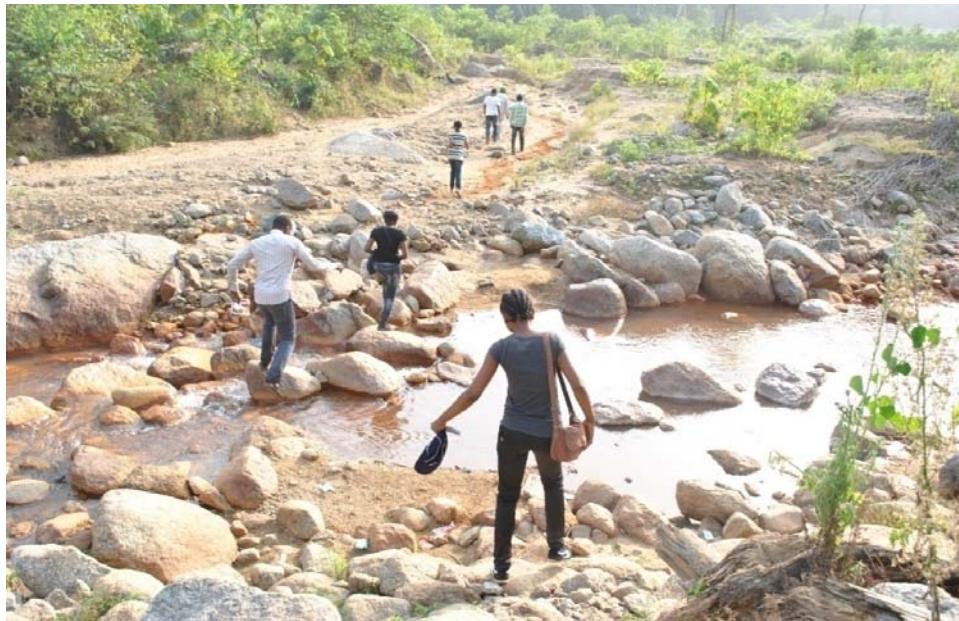
Plate 3b: Field photograph showing geosciences students accessing the foot of the highlands flow route of the rockslides about 2km.

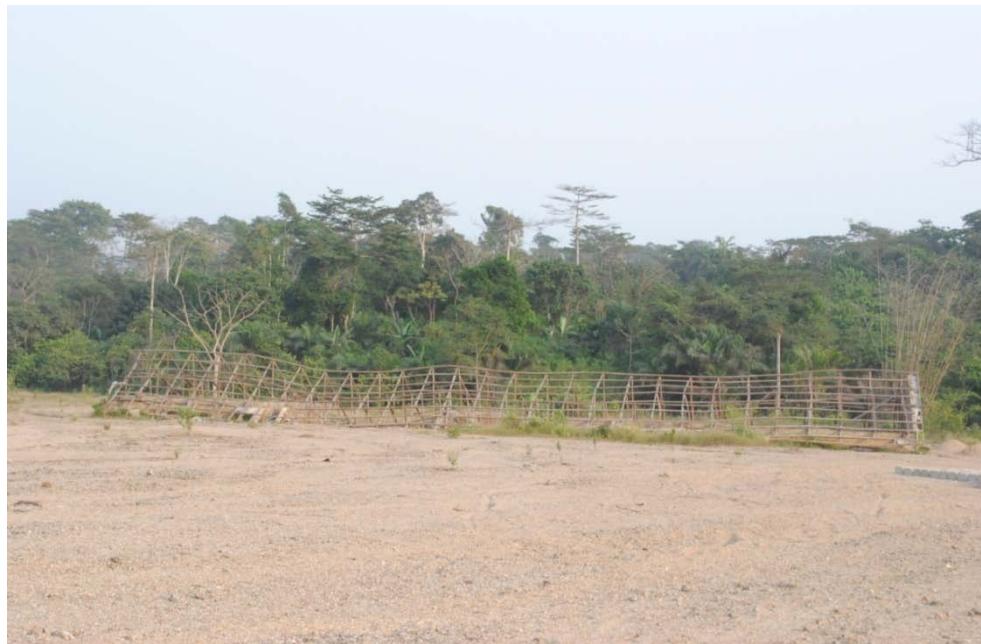
Plate 4: Field photograph showing what is left of the damaged six classroom block at Community Secondary School Buanchor after the rockslides.

Plate 4, is a damaged six class room block of Community Secondary School Buanchor which is about 1km from the foot of the highlands after the rockfalls and rockslides in the area, while plate 5 is the Walkaway part which are usually connected to trees, was also damaged as the trees were equally affected at about

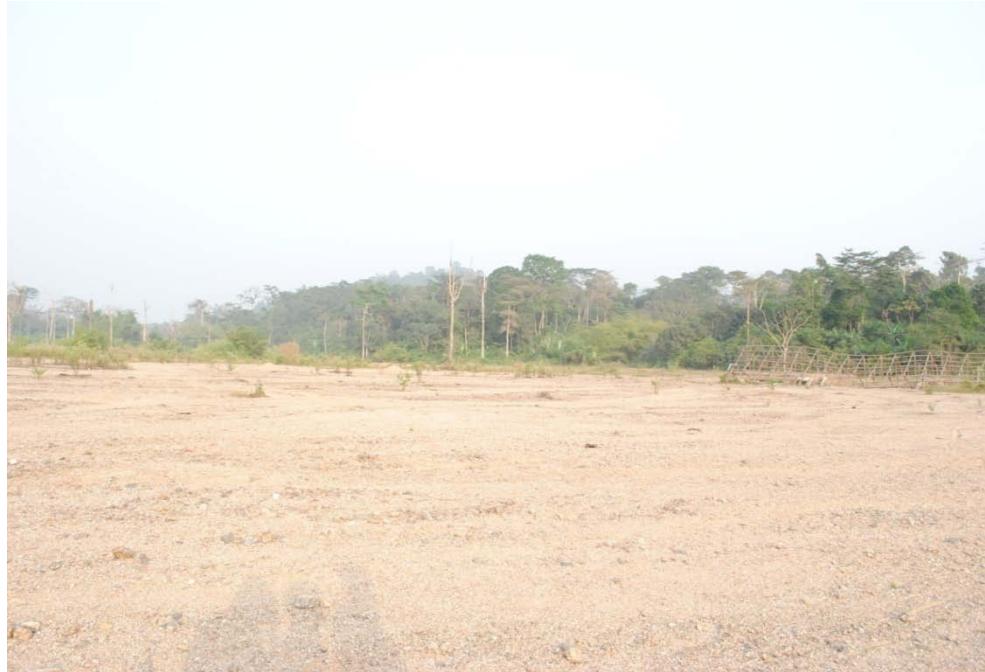
Plate 6: Field photograph of the damage to farmlands and a 400m Walkway at Buanchor

2km from the highlands. The farmlands were also washed off and filled with sands and gravels (plate 6). The methods of controls on any identified slope prone to rockfalls and rockslides or have been affected by such geohazards are protected with rock netting as shown on plate 7.

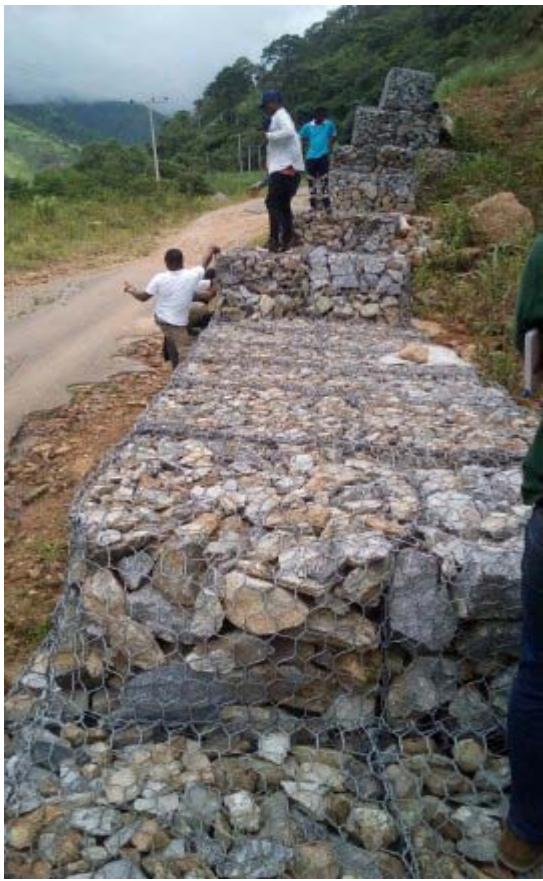
Plate 7: Rock netting a method for protecting critical infrastructure like road and human settlements near Obudu Plateau cattle ranch gate
