Water Quality Evaluation of Hand-Dug Wells in Ibadan, Oyo State, Nigeria

By Ayantobo O. O, Oluwasanya G. O, Idowu O. A & Eruola A. O

Federal University of Agriculture, Nigeria

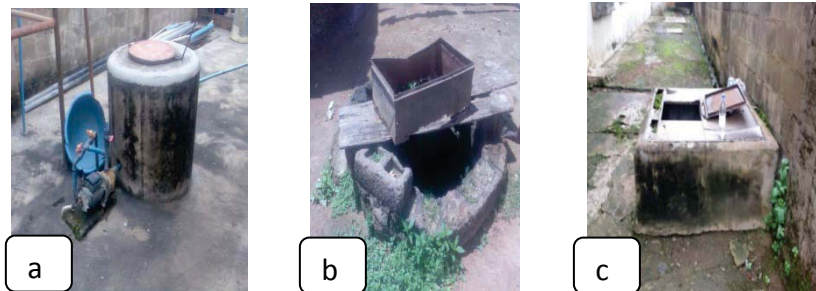
Figure 2 : Construction patterns of selected wells- a: protected well; b: unprotected well; c: semi-protected well

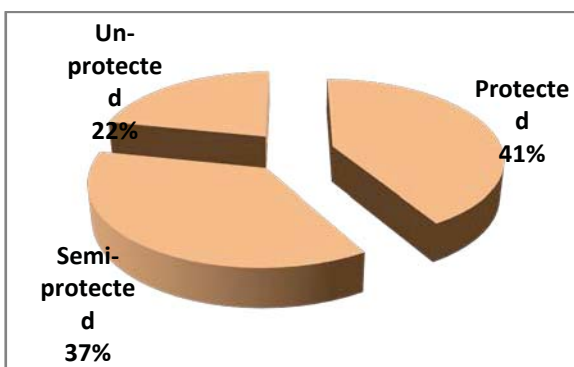
The number of selected wells that fits into each well classification is presented in Table 2. Forty one percent (42) of the hand-dug wells are protected, 37% (37) and 22% (22) of the wells are semi-protected respectively (Figure 3).

Figure 3 : Construction patterns of hand-dug wells

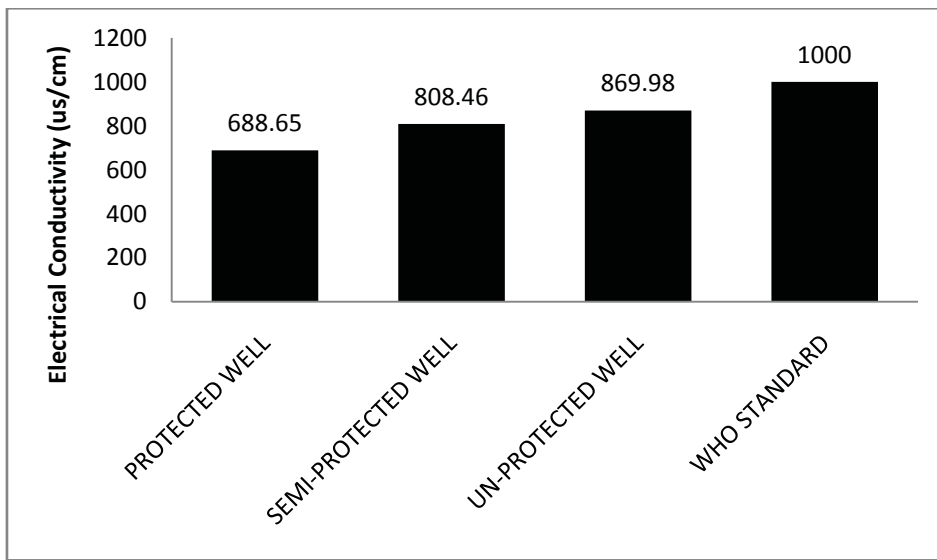
The result of water analysis for different well classification is presented in Table 3. Table 3 shows that the highest average value of 869.98 us/cm was recorded for electrical conductivity in unprotected well relative to 688.65 us/cm and 808.46 us/cm that was recorded in protected and semi- protected respectively (Table 3 and Figure 4). The recorded high EC in unprotected wells may be due to direct ingress of water due to poor well construction. However, all of the recorded values are below the recommended value of 1000 us/cm (WHO, 2011; NDWQS, 2007).

Figure 4 : Average level of electrical conductivity in hand-dug wells

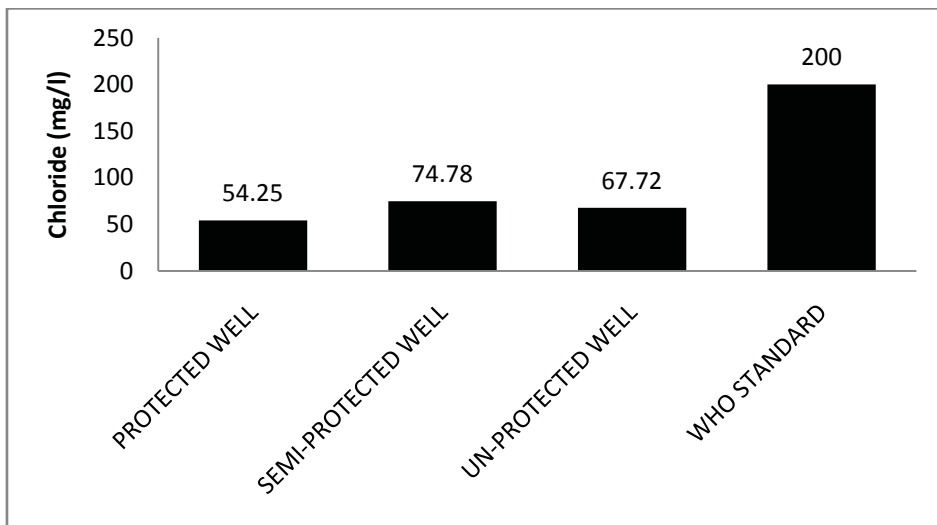
The average chloride values ranges from 54.25mg/l for protected well, 74.8mg/l for semi-protected well and 67.73mg/l for un-protected well (Table 3 and Figure 5). All this values are below the recommended WHO (2011) value of 200mg/l for drinking water.

Figure 4 : Average values of Chlorides in hand-dug wells

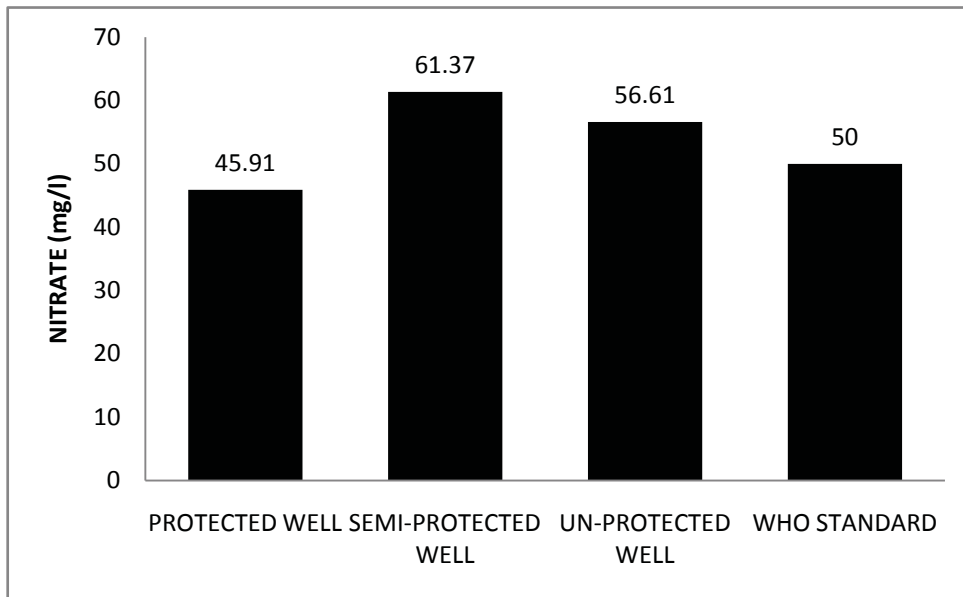
Elevated nitrate were identified in the unprotected and semi-protected samples tested, with average values of 61.37 mg/l and 56.62 mg/l respectively compared to the protected well with an average value of 43.19 mg/l (Table 3 and Figure 6). Most of the semi-protected and the un-protected wells have nitrate concentrations higher than the WHO (2011) recommended value of 50 mg/l for drinking water.

Figure 5 : Average values of Nitrate in hand-dug wells

Nitrate has known human health impacts, primarily in infants. Nitrate affects haemoglobin in the blood and reduces the babies' ability to transport oxygen; infants so affected are said to have 'blue baby syndrome'. There is also a 'suspected link between exposure to nitrate and cancer in human (WHO, 2004). The most common origins of nitrate in groundwater within the study area are agricultural activities and disposal of untreated human waste.

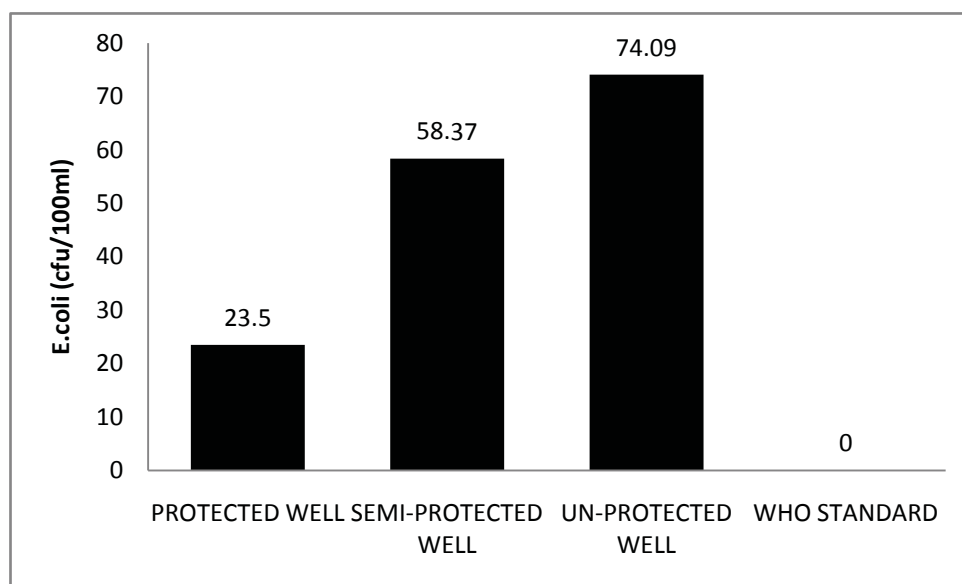
Furthermore, the results showed that all water samples contained E. coli that does not conform to the maximum contaminant level of 0cfu/100ml. The E. coli in protected well ranges between 0-90cfu/100 ml, while in semi-protected and unprotected well, it ranges from 0 - 120cfu/100ml and 0 - 270cfu/100ml respectively (Figure 7).

Figure 6 : Average values of E. coli in hand- dug wells

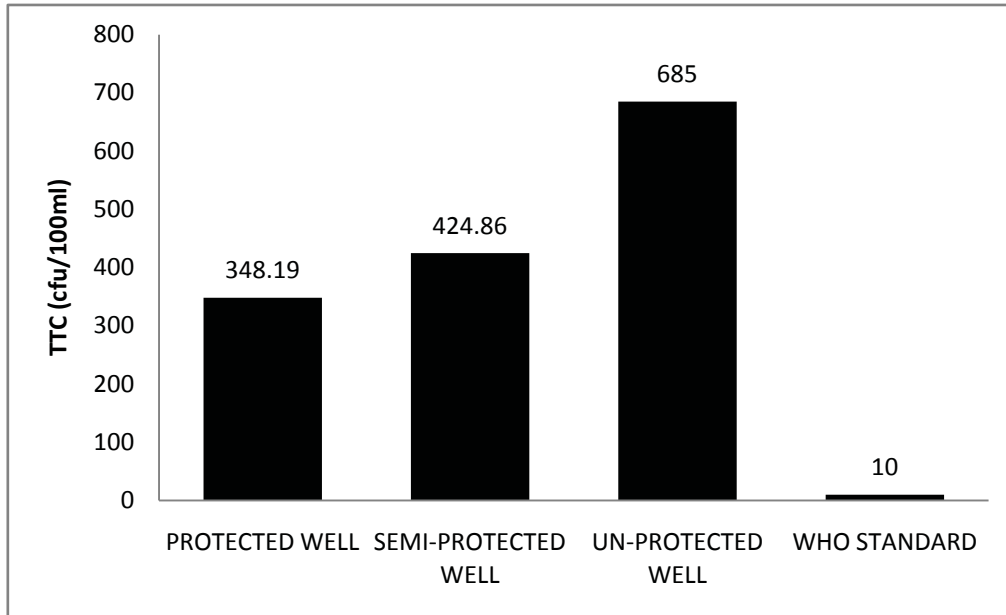
From the result of the analysis on TTC , it was observed that all the tested samples have detectable amount of TTC, with concentration ranging from 0-1260 cfu/100 ml for protected, 120-840cfu/100ml for semi-protected and 210-1420cfu/100ml for unprotected wells (Table 3 and Figure 8), as against the WHO (2011) acceptable limit of 10 cfu/100ml for potable water. This is an indication of faecal contamination.

Figure 7 : Average values of Total Coliform Count in hand-dug wells

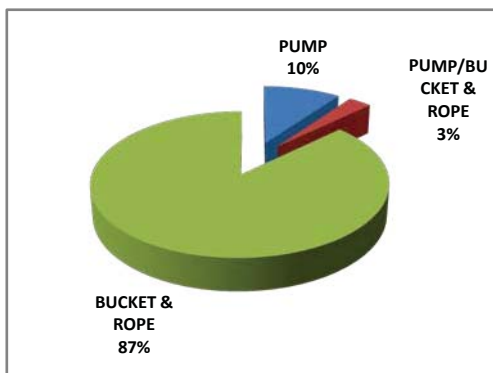
Observations during survey shows that possible contamination during abstraction because 3% of the hand-dug wells were operated with both pump and bucket & rope while 10% are operated through a motorized pump and 87% of the hand-dug wells were operated through bucket and rope gotten from different sources. This implies that high level of contamination during abstraction will be expected (Table 3 and Figure 8).

Figure 8 : Means of hand-dug wells Abstraction
