GLOBAL JOURNAL OF RESEARCHES IN ENGINEERING
CIVIL AND STRUCTURAL ENGINEERING
Volume 13 Issue 2 Version 1.0 Year 2013
Type: Double Blind Peer Reviewed International Research Journal
Publisher: Global Journals Inc. (USA)
Online ISSN: 2249-4596 & Print ISSN: 0975-5861

Investigation into Effects of Construction Moisture Content on Inerted Manganese Product Stiffness in Road Pavement Layers

By J. Strydom & WJvdM Steyn

University of Pretoria, South Africa

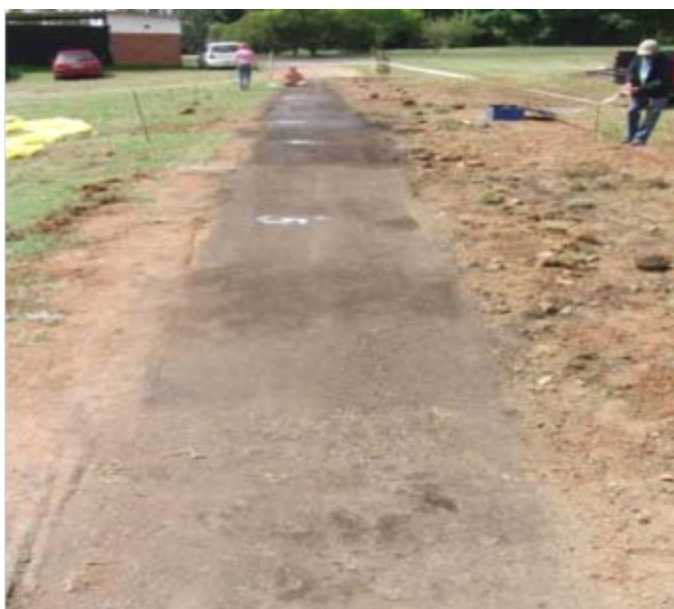
Figure 1 : Layout of experimental test sections

Five test sections were constructed at different moisture contents (OMC = 26.4 per cent) as indicated in Table 1. The moisture contents were selected based on field experience indicating viable moisture content values to enable adequate compaction. Test sections consisted of a 5 m long, 1 m wide and 150 mm thick IMP layer, on top of compacted in-situ material. In practice the IMP layers are sealed with a bituminous surfacing, however, the reported sections were constructed and evaluated without this surfacing, as a curing period of ninety days is typically allowed and the duration of this study was less than 90 days. The layout of the test sections is shown in Figure 1.
